## Site Visit Report

**Project Name:** Elkins Main Street

**Project #:** Darden House

**Date:** May 3, 2021,

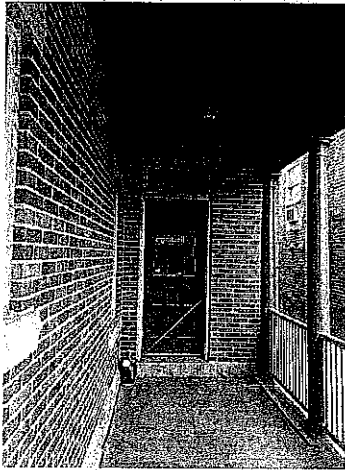
Note that the porch columns are resting directly on the porch tongue and groove flooring. The existing bases should be replaced with cast bases that allow air circulation. This will allow the column to breathe if they are hollow. Install vent opening at the top. The existing columns are hollow and they should be able to breathe.

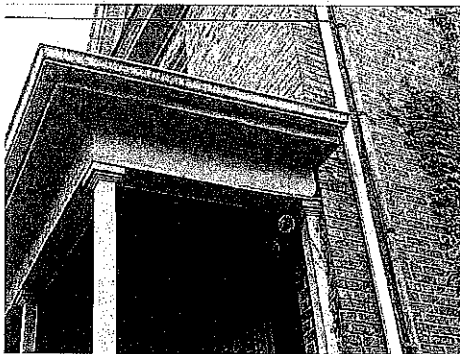
The fascia on the rear porch on the south elevation behind the gutter shows some signs of deterioration. It should be repaired. The frieze band, where it meets the west wall of the house, shows deterioration at that location. It may require a new section or may need to be consolidated or epoxied. The frieze board of the west elevation shows much paint delamination and deterioration.

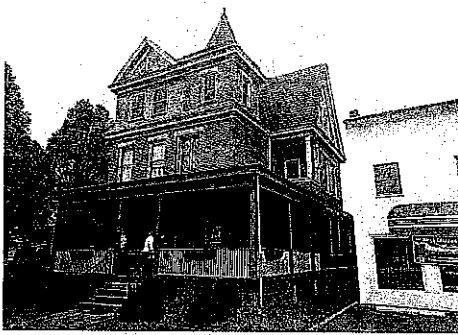
The front porch requires repair and painting.

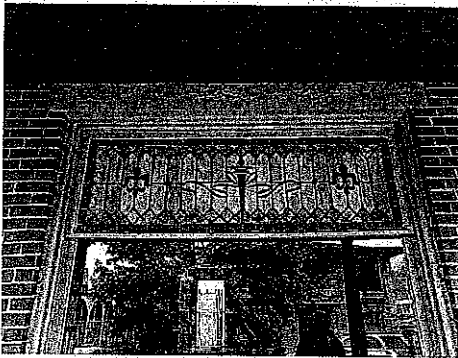
The large front window on the first floor has a bow in the bottom rail of the top sash/transom. It is possible this is too wide a window to support itself with the existing bottom rail.

This should be repaired. It may be possible to install a bronze rod or cable in the center of the rail, supported by the top rail or the window head. It may also be possible to install a channel or angle along the bottom rail that would supplement the wood rail. If this approach is taken, insure that this installation does not trap moisture against the bottom rail and cause deterioration. The upper sash is also supported or blocked by nails at the jambs. These should be replaced with a more permanent block support at the corners of the sash.
